SLIPLINING IN EDMONTON

EPCOR Project Rehabilitates Groat Road Sewer

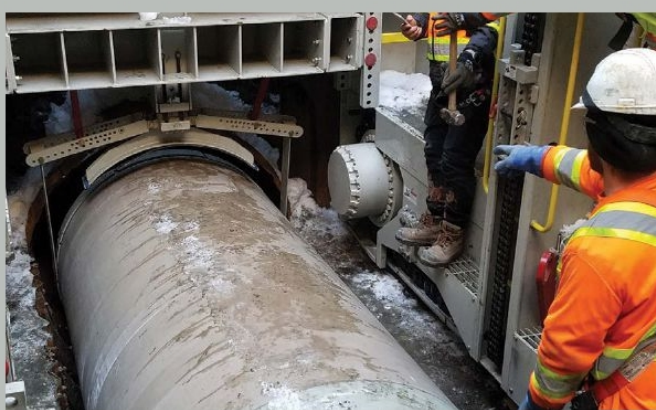
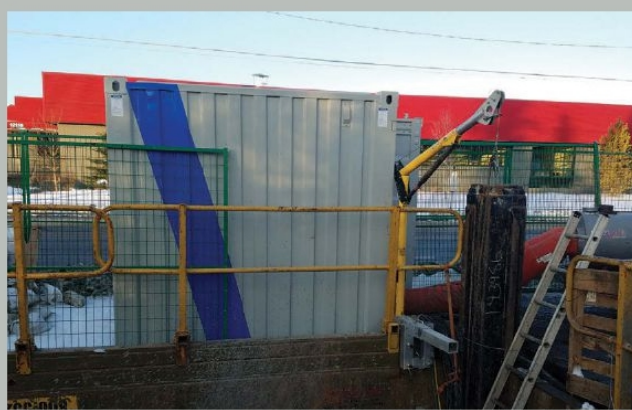
ing would be, "arduous." To negate this effect, the contractor permanently affixed tracks to the invert of the host pipe. The Hobas pipes were then slid along these rails for the length of the project. It was proved to be an effective way to slipline pipes in corrugated metal pipes.

The third major challenge came in spring 2019 when the winter's ice melted leading to high flows inside the newly-installed pipe. Though the liner was anchored, crews used the retention winch on the Akkerman machine and wood wedges to hold the liners in place before the annular space between the FRP pipes and the corrugated metal pipes were filled.
