TBM PROVIDES VERSATILITY IN DIFFICULT GROUND FOR WATER CONVEYANCE TUNNEL IN EL PASO, TX

GUIDED BORING TO THE RESCUE FOR EMERGENCY RESIDENTIAL AREA STORMWATER REPLACEMENT

IDENTIFYING PILOT TUBE WEAR

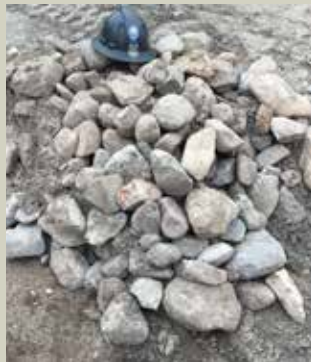
CONTRACTOR:
BRH-Garver Construction LP

LOCATION: El Paso, TX

GROUND CONDITIONS:
Standing sand and cobbles

PIPE: 66-in. Permalok®

TOTAL LENGTH/LONGEST RUN:
885-lf./570-lf.

AKKERMAN EQUIPMENT:
TBM 480 Tunnel Boring System, P600E
Electric Power Pack

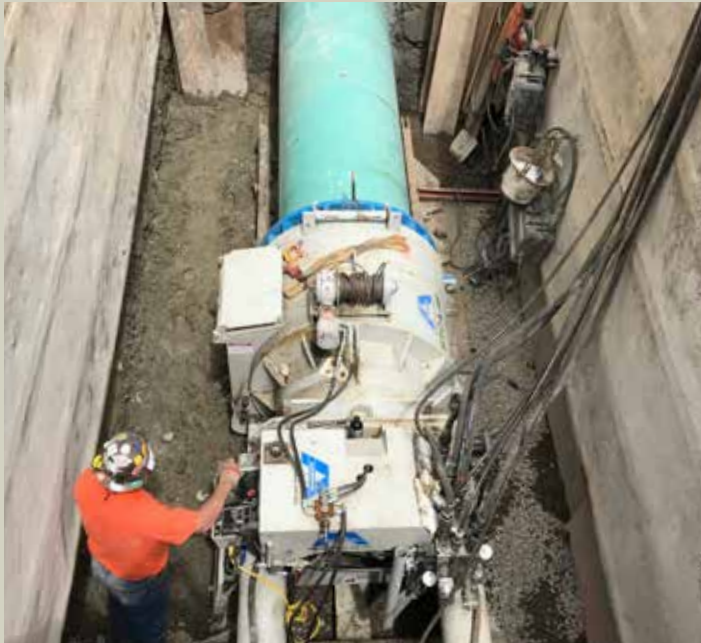
CONTRACTOR: Northwest Boring Co. Inc.

GROUND CONDITIONS: Glacial till with rocks

PIPE: 36-in. OD steel casing, 27-in. Vylon® carrier

TOTAL LENGTH/LONGEST RUN: 250-lf./140-lf.

AKKERMAN EQUIPMENT:

GBM 4800 Series, High-Torque Casing Adapter (HTCA), Guide Rod Swivel (GRS) 50 36-in., Rock Drill Adapter with TriHawk® drill bit

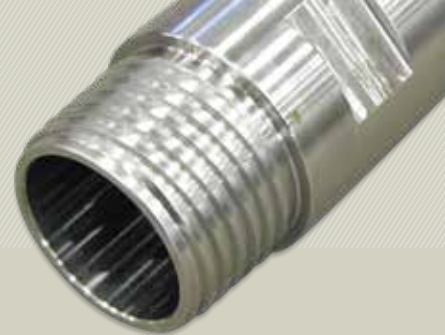
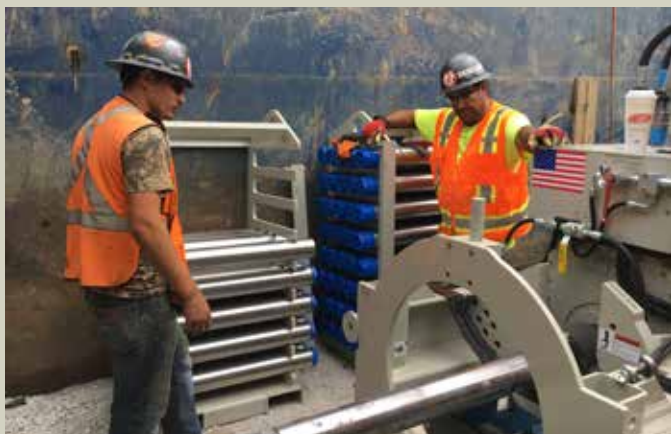
Thread wear and ballooning is what transpires over time and is caused by excessive side-loading and high torque. This reduces the thread's engagement and this loss of face adds additional stress to the female end of the pilot tube.

Use the thread gauge tool to compare the threads to new pilot tubes (see Figure 1), making thread wear more apparent.

If you look at a cut-away view of two mated pilot tubes where ballooning has occurred, you will notice that the thread teeth show rounding at each crest (see Figure 2). The rounding diminishes the rigidity of the connection, lessens the maximum rotational torque capacity and could fatigue the tube to failure.

When pilot tubes are in good condition, the exterior join region should be smooth (see Figure 3). When running your finger along this area there should be no step or overlap. When threads are worn and ballooning has occurred, there will be a noticeable overlap in this region (see Figure 4).

- Loss of face at points of thread engagement
- Difficulty separating tubes during breakout
- Thread teeth show rounding at each crest
- Exterior join of two pilot tubes shows overlap

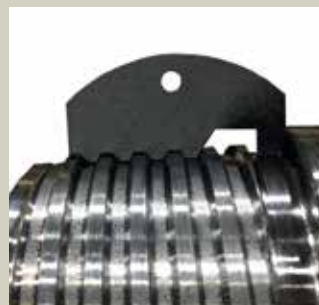
Figure 1. Pilot tube presenting a good thread wear pattern.

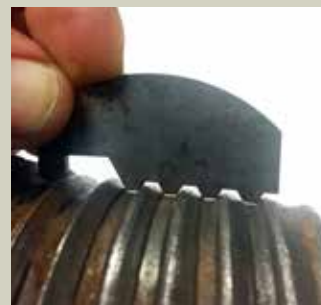
Figure 2. Pilot tube presenting worn threads.

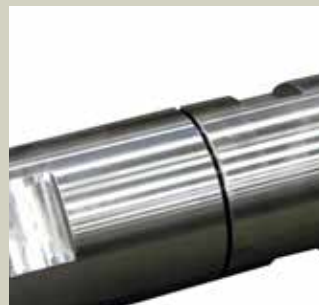
Figure 3. Good, smooth pilot tube connection.

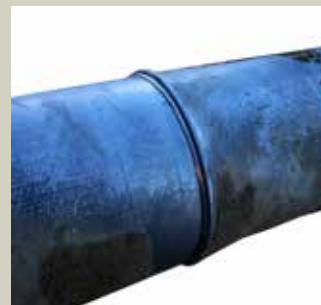
Figure 4. Pilot tube connection presenting ballooning.

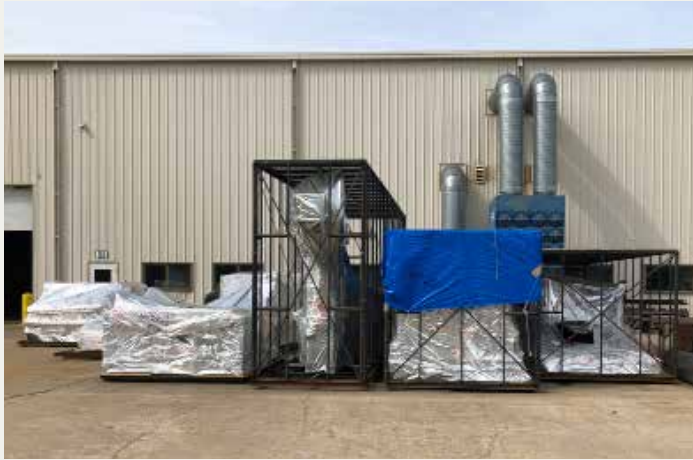
A glimpse of the mass of individually wrapped components delivered on seven tractor and trailers.

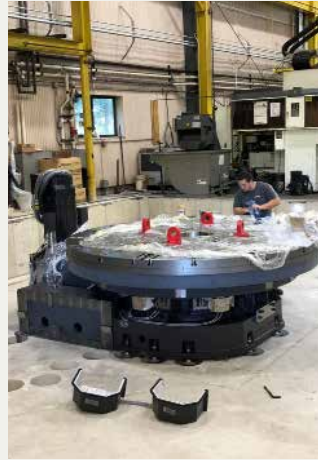
Installation of the boring mill.

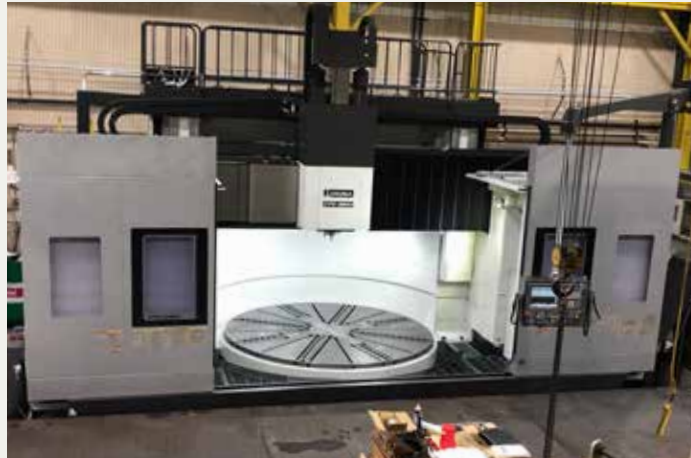
Nearing the final stages of installation.
