CASE STUDY

PIPE JACKING | SLURRY MICROTUNNELING

Project Name:
Aurora Gun Club Rd. Microtunneling Project

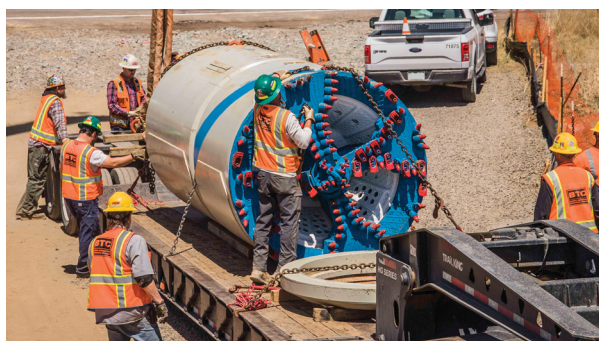
The Akkerman SL60C-72 outfitted with a dual-gage soft ground cutterhead is shown being delivered to the jobsite. The Akkerman MTBM received an increased kit to 72-in OD that included a belly-pan kit to assist steering reaction along the alignment.

- **Customized Equipment Configuration:** The Akkerman SL60C MTBM was fitted with a dual-gage soft ground cutterhead and upgraded to a 72-inch OD using a specialized skin kit. This ensured optimal performance and face pressure control in soft ground.
- **Belly-Pan Kit for Steering Support:** A belly-pan steering kit was added to enhance machine stability and alignment control through the variable soil profile.
- **High-Capacity Jacking Frame:** An 800-ton jacking frame provided consistent and sufficient thrust force to advance the steel casing without overloading or causing buckling.
